Die Crack Detection in HVM is Critical for High Reliability Applications

DAMON TSAI, Rudolph Technologies, Inc., Wilmington, MA

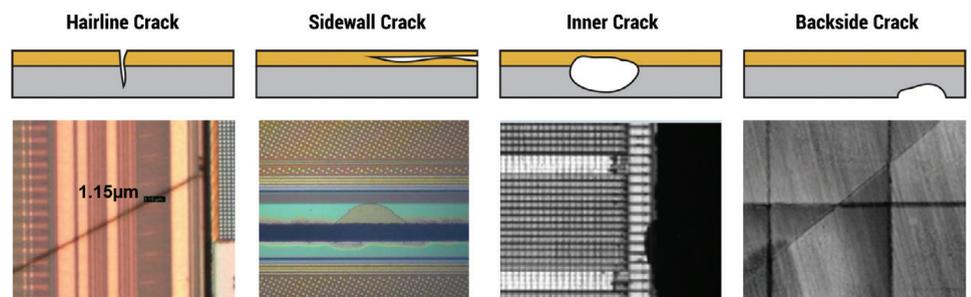
Figure 1. Die cracks are generally associated with the dicing process and may be conveniently categorized as hairline, sidewall, inner, or backside. Each has distinct causes and requires a different approach to optimize detection. The upper row contains diagrammatic representations of these types. The bottom row shows the appearance in the inspection optical system.

DIE CRACKS COME IN SEVERAL TYPES (Figure 1), each requiring a different approach to optimize detection. Hairline cracks occur at the surface. They are small and shallow and show low contrast in inspection images. Sidewall cracks penetrate the die from the sidewall (the die edge), roughly in the plane of the die, and seem to be directly associated with the dicing process. Inner cracks are similar to sidewall cracks but may occur anywhere in the die and are likely caused by stresses introduced at other stages in the process. Backside cracks originate in the wafer substrate and often continue across multiple die.

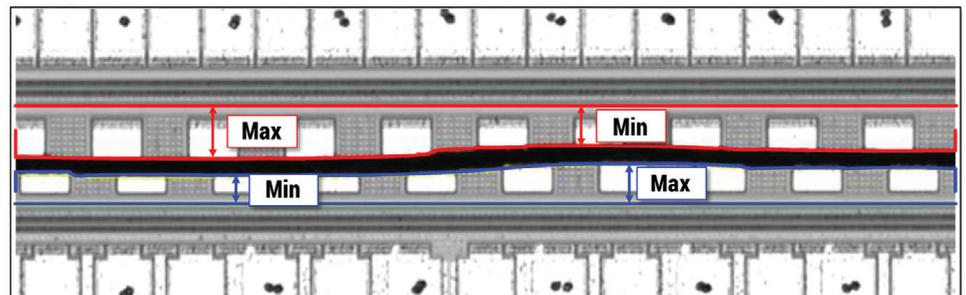
Figure 2. The occurrence of die cracks can be reduced by careful control of the dicing process to ensure that the saw kerf remains well centered between the die.

process requires the ability to automatically discern the die seal ring and active area and measure the location of the kerf relative to them (Figure 2). Accurate, repeatable measurements of kerf location enable improvements in the dicing process that can significantly reduce the penetration of cracks into the active area. A growing number of automotive customers are requiring automated kerf inspection.

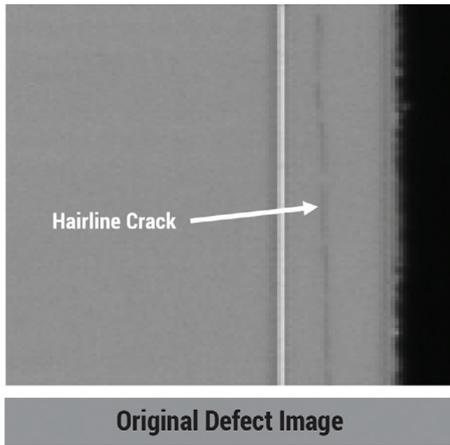
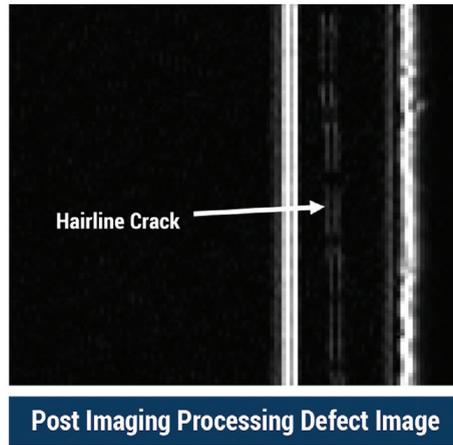
Figure 3. Image processing can improve the apparent size and contrast of tiny hairline cracks. In the image on the left (5X brightfield with a red filter) the crack is only two pixels wide and 10 gray scale levels. In the processed image on the right the same crack is 4 pixels and 40-50 gray scale levels. The processing algorithm uses spatial filtering to eliminate noise and improve uniformity near the die edge.

The primary challenge with hairline cracks is their small size and low contrast in inspection images. Figure 3 shows images of a crack before and after the application of image processing algorithms designed to enhance the visibility of hairline cracks. Spatial filtering improves the signal to noise ratio, resulting in a doubling of the apparent width of the crack and a 4-5X increase in contrast.

The algorithm is also designed to improve uniformity near the edge of the die where cracks are most likely. The overall result is an improvement in detectability and reduction in nuisance defects.

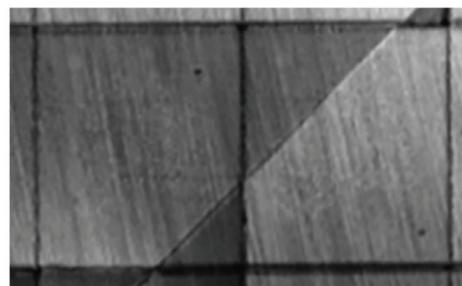
Backside Inspection

Figure 5. Backside cracks that are obvious when viewed from the back can be hard to see when viewed from the front. Inspecting the backside without contacting the active areas of the die requires special handling capabilities.

without damaging the active area on the frontside. Flipping the film frame requires a film frame inverter. Once inverted, inspection without contacting the front surface requires a specially designed chuck in which the central portion, corresponding to the active area, can be retracted below the chuck surface to avoid contact. Figure 5 shows a section of a wafer containing several die from the back (left) and from the front (right). Cracks that are difficult to

distinguish from the front are clearly visible from the back.
